**Flood Control Project Maintenance  
Levee Inspections****LMA District Cover Sheet****Spring 2011 Levee Inspection Results****Reclamation District No. 2091 Chase**

**Levee Inspection Report By Mile - Spring 2011**

**Reclamation District No. 2091 Chase**

Waterway	Bank	Unit Miles	Inspection Start/End	Inspector
Unit No. 01 San Joaquin River	Right	7.59	05/17/2011 05/17/2011	Richard Willoughby

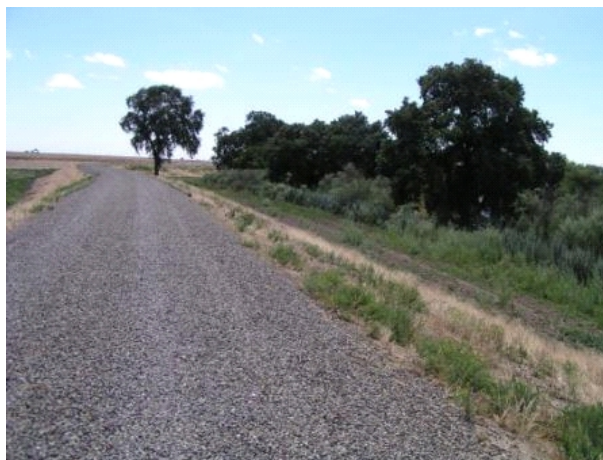
Levee Mile Report Line	1
Start Levee Mile	0.00
End Levee Mile	7.59
Location	Crown
Category	Earthen Levee
Item	Crown Surface / Depressions / Rutting

Looking at typical view of levee crown

LMR No.	Levee Mile		Category	Item	* Location	** Rating	Action/Comment	GPS Latitude/Longitude		Issue No. Photo
	Start	End						Start	End	
1	0.00	7.59	Earthen Levee	Crown Surface / Depressions / Rutting	CR	M	Keep the crown roadway free of vegetation.	37.541479 ° -121.092845 °	37.478860 ° -121.044650 °	6 Y
2	0.00	7.59	Earthen Levee	Vegetation	LS	M	Control annual grass and weeds on the levee slopes and easements.	37.541479 ° -121.092845 °	37.478860 ° -121.044649 °	1 Y
3	0.00	7.59	Earthen Levee	Vegetation	WS	M	Control annual grass and weeds on the levee slopes and easements.	37.541479 ° -121.092845 °	37.478860 ° -121.044649 °	2 Y

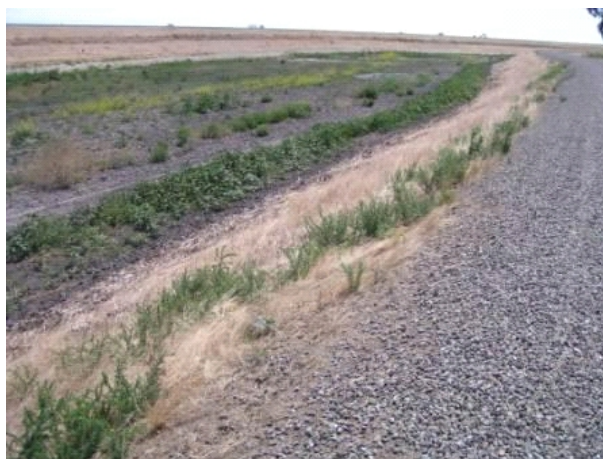
Levee Mile Report Line	2
Start Levee Mile	0.00
End Levee Mile	7.59
Location	Land Side
Category	Earthen Levee
Item	Vegetation

Looking at typical view of levee landside.

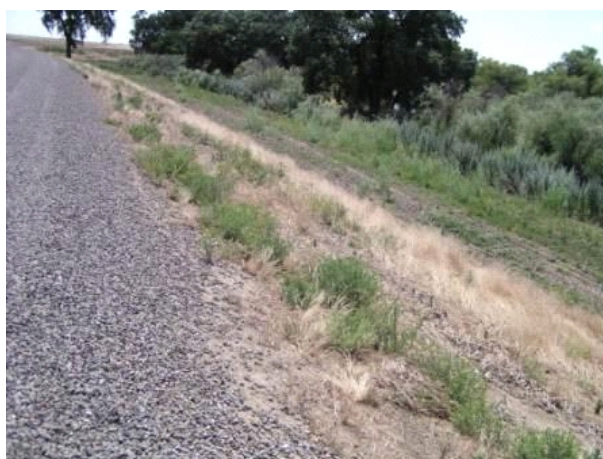
Levee Mile Report Line	3
Start Levee Mile	0.00
End Levee Mile	7.59
Location	Water Side
Category	Earthen Levee
Item	Vegetation

Looking at typical waterside view of levee Spring 2010

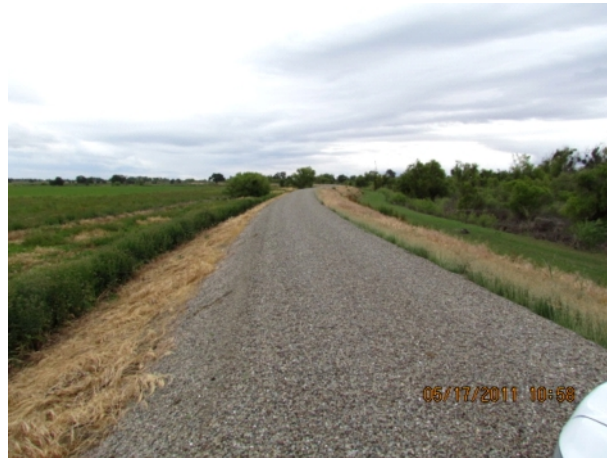
Levee Mile Report Line	3
Start Levee Mile	0.00
End Levee Mile	7.59
Location	Water Side
Category	Earthen Levee
Item	Vegetation
Looking at typical view of levee Spring 2011	
richard_s_20110524_541.jpg

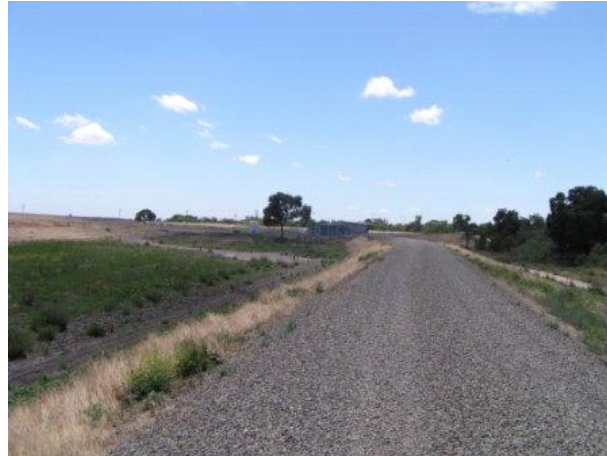
Levee Mile Report Line	1
Start Levee Mile	0.00
End Levee Mile	0.33
Location	Land Side
Category	Earthen Levee
Item	Vegetation

Looking at typical view of levee

LMR No.	Levee Mile		Category	Item	* Location	** Rating	Action/Comment	GPS Latitude/Longitude		Issue No.
	Start	End						Start	End	Photo
1	0.00	0.33	Earthen Levee	Vegetation	LS	M	Control annual grass and weeds on the levee slopes and easements.	37.482214 ° -121.051475 °	37.485550 ° -121.049145 °	1 Y
2	0.00	0.33	Earthen Levee	Vegetation	WS	M	Control annual grass and weeds on the levee slopes and easements.	37.482214 ° -121.051475 °	37.485550 ° -121.049145 °	2 Y

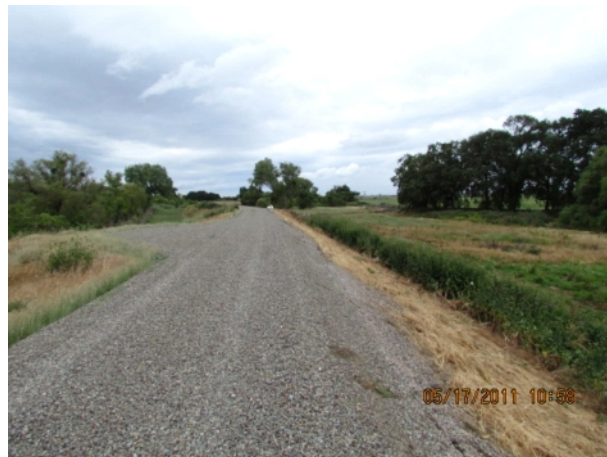
Levee Mile Report Line	2
Start Levee Mile	0.00
End Levee Mile	0.33
Location	Water Side
Category	Earthen Levee
Item	Vegetation

Looking at typical view of levee Spring 2011
